## ON-SITE REFURBISHMENT AND HV TESTS OF LARGE POWER TRANSFORMERS IN THE HUNGARIAN TRANSMISSION GRID

### Abstract:

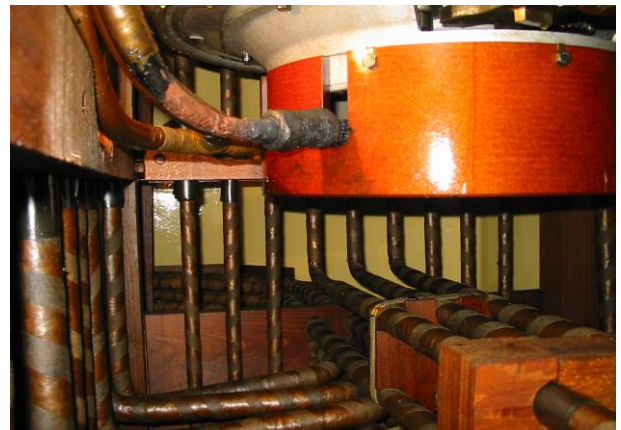
Regarding the diagnostic data it was obvious that the windings weren't damaged but they have got local overheating area therefore at first step it had to try to repair on-site and not in the factory. After the removing the oil the un-tanking technique was used with the CRAB lifting system. After the un-tanking processes, it was found that the paper insulation on a short section of the OLTC connections was almost burned out, the insulation was carbonised and the copper conductors were consumed in a great extent (Figure 4).

**Figure 4:** paper carbonisation and burning out phenomena on the OLTC connection

Regarding the special profile of the copper conductor and the carbonised insulation it was obvious that during the short opening hours it is impossible to change this part that's why it had to open the transformer once more. During the first part of the overhaul, the iron core and the coils were retightened. After consulting the OLTC factory a decision was taken about the prefabrication of the insulated copper conductor with special profile and building in to the transformer during the second opening of the transformer.

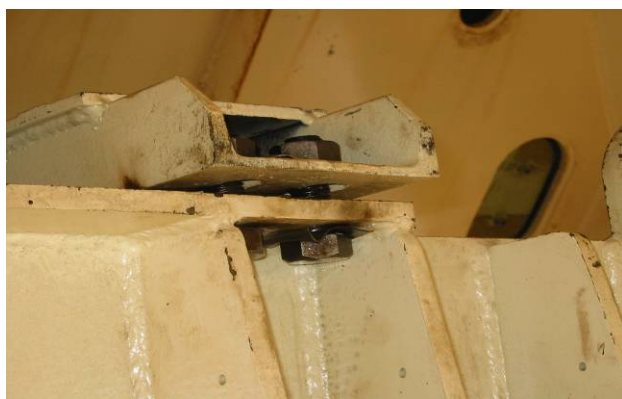
After a long-term service of transformer it was obvious the reduction in clamping pressure but in this case the loosening of core and the winding was relatively large (Figure 5). In this case, the main goal is to extend the lifetime of the active part through targeted maintenance operations on the repressing the windings and core. But if the transformer is open the main equipment parts, namely, the OLTC and its control panel, the cooling system, the cabinets have been refurbished, too.

**Figure 5:** strong looseness in the core of transformer

After the opening the transformer the first inspection always consists in checking that the transformer's active part does not suffer from an incipient fault, the geometric deformation of the windings, displacement of winding (significant displacement in the axial direction), buckling of winding (significant displacement in the radial direction). It is important to have an estimation of the residual tightening of the windings as this significantly conditions the mechanical withstand of the transformer at the time of a short circuit. During the overhaul, the iron core and the coils were retightened. At the end all parameters of transformer after the repair, including its dielectric loss factor, RVM spectrum, the reduction of vibration, etc. meet the requirements. The decision to carry out onsite repairs of this transformer at the stations has resulted in considerable time and cost saving and helped in maintaining desired availability. After five months repair the transformer was switched back into service and has operated without any further problem ever since.
