GLASS CAP-AND-PIN INSULATOR STRINGS UNDER HVDC CONDITIONS: PRELIMINARY RESULTS OF INVESTIGATIONS INTO THE INFLUENCE OF SHATTERED DISCS ON INSULATION STRENGTH

N. Parus^{1*}, N. Mahatho¹, T. Govender¹, E. Marshall¹, P.V. Goosen¹
E. Greyling¹ and G.C Sibilant²

¹Eskom Holdings SOC Ltd, Johannesburg, South Africa

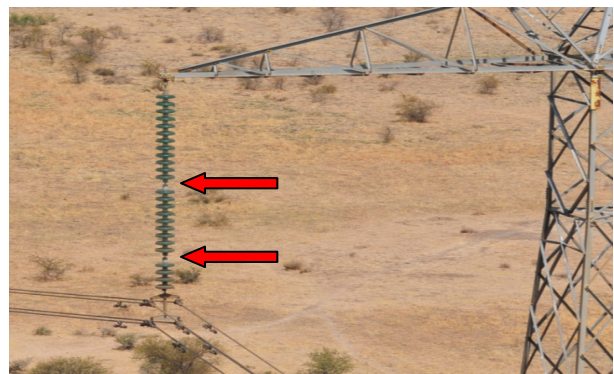
Glass insulators are prone to vandalism and line inspections have shown that some glass strings have randomly positioned shattered discs. It is assumed that this condition may affect the total insulation strength of the string.

Figure 1: Photograph of shattered discs (indicated by red arrows)

It is proposed that live line maintenance work be conducted to repair or replace these discs or strings. At present, live work is not being conducted at full system voltage and is limited to minor maintenance work. The system voltage is

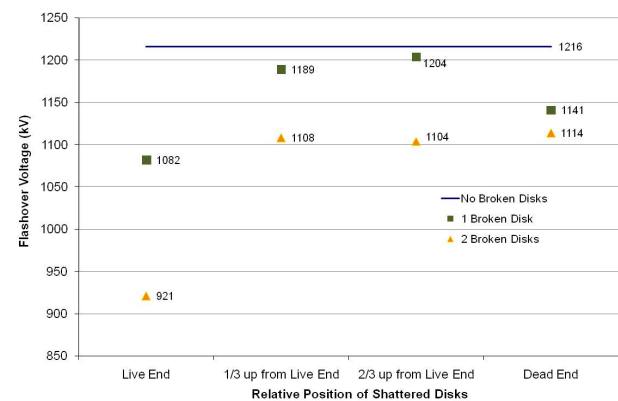
Figure 7: Results of the breakdown voltage in the presence of shattered glass discs placed at different positions in the string.

It is observed that shattered discs results in a definite decrease in insulation strength. The worst effect is seen for the case where the shattered discs are located at the live end of the string. The images below are recorded by a high speed digital camera. It is noted that there is a spark-over across the dead end disc prior to the breakdown of the full air gap.

- For a 13 string insulator, two broken discs at the live end of the string results in the worst flashover performance - a 24% reduction in flashover voltage.

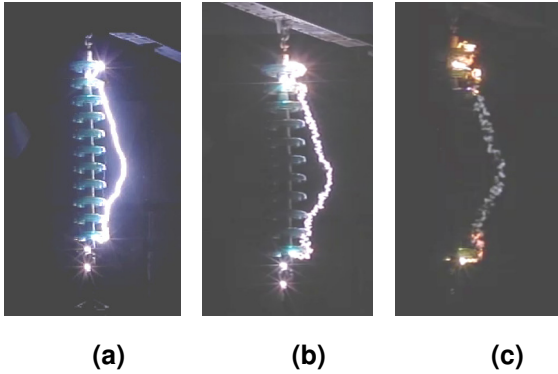
Figure 8: Flashover event sequence - 2 broken discs at live end

It was observed that the flash occurs between the partial flashed over dead end disc and the first healthy disc at the live-end. High levels of corona emission were observed on the metal fittings of the two shattered discs.

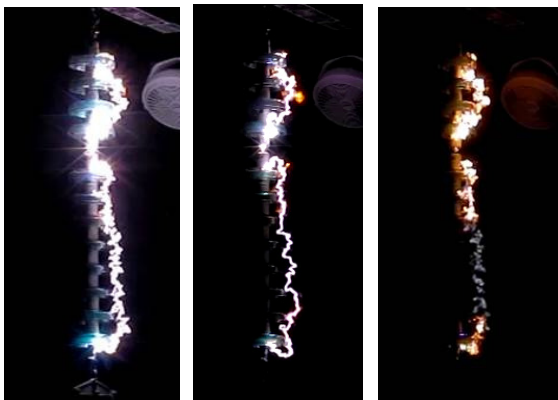
Figure 9: Sequence showing flashover when one single shattered disc is located one third up the string

It was observed that the flashover terminated on the shattered disc and did not bridge the entire air gap. Several discharge pulses were observed during one flashover event.

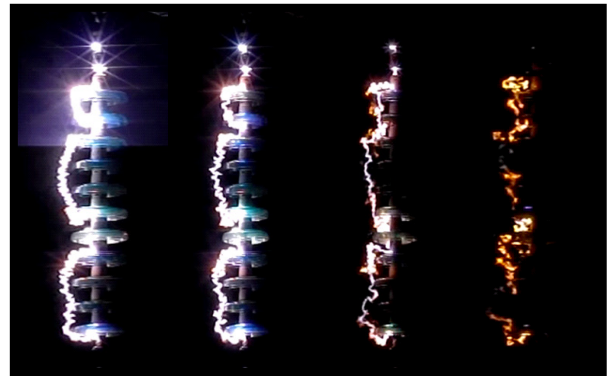
Figure 10 shows the resultant flashover for two broken discs located at the dead-end. It was observed that the arc was not continuous. It terminated before the fifth and tenth disc respectively.

Figure 10: Sequence showing flashover with two broken discs at the dead-end

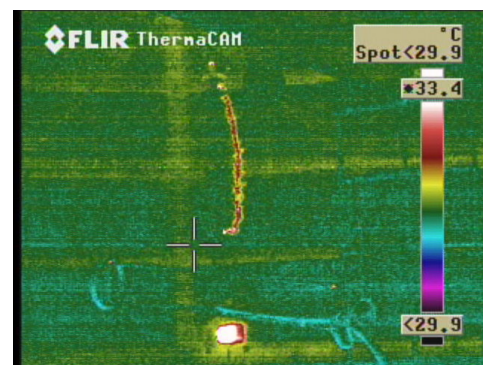
Figure 11: Infrared camera image (one broken disc at the dead-end)

Hot spots on the cap and pin of the damaged insulator were observed during the test. No noticeable heating was noted prior to the breakdown.

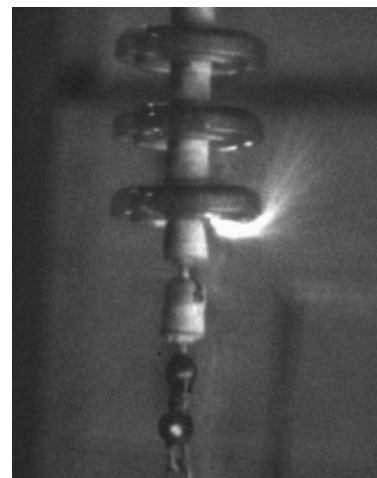
Excessive corona were observed on certain discs for the shattered disc cases.

Figure 12: Corona emanating from first healthy live end disc (2 broken discs at live end)

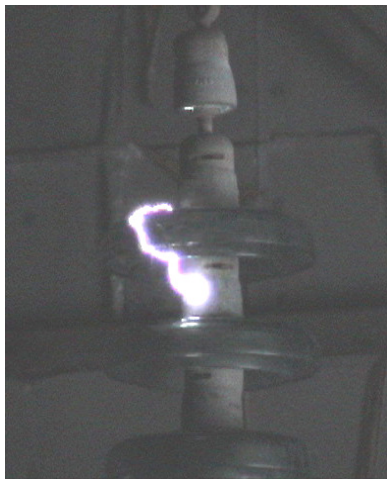
For some tests, partial flashover of some discs was observed prior to complete flashover of the entire string. This may be attributed to non-uniform voltage distribution across the string [5].

Figure 13: Single disc (partial) flashover for the case of one broken disc at the dead-end.

It was noted that for certain tests, the partial dead-end flashover occurred between 84-95% of the final flashover voltage. Further work is required in order to investigate and understand this phenomenon.
