## INVESTIGATION OF THE EFFECTS OF THE PRESENCE OF LARGE BIRDS ON OVERHEAD LINE STRUCTURES IN BRAZIL

R. W. S. Garcia

Electric Energy Research Center - CEPEL

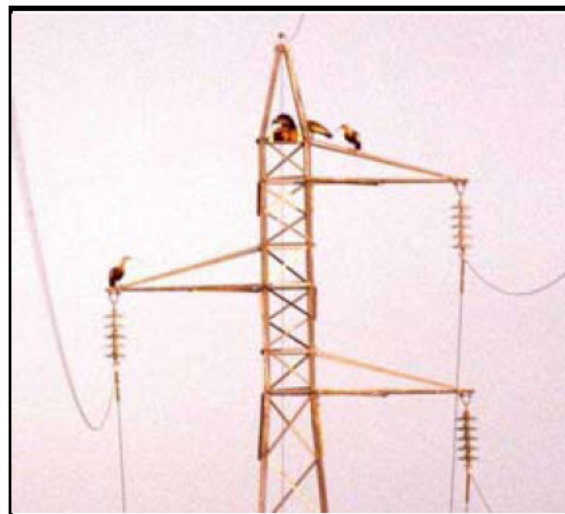
After inspections CEMIG's technicians have noted flashover marks on conductors, fittings and crossarms in many towers. Talking with people that live in that region they have known about birds which roost on the towers during the night and have concluded that the problem was related to

the presence of Curicacas in the towers, as seen in Figure 3 and after comparing these results with data obtained in the literature they have confirmed the causes were bird streamers.

**Figure 3:** Curicacas perched on metallic tower of 69 kV TL [5]

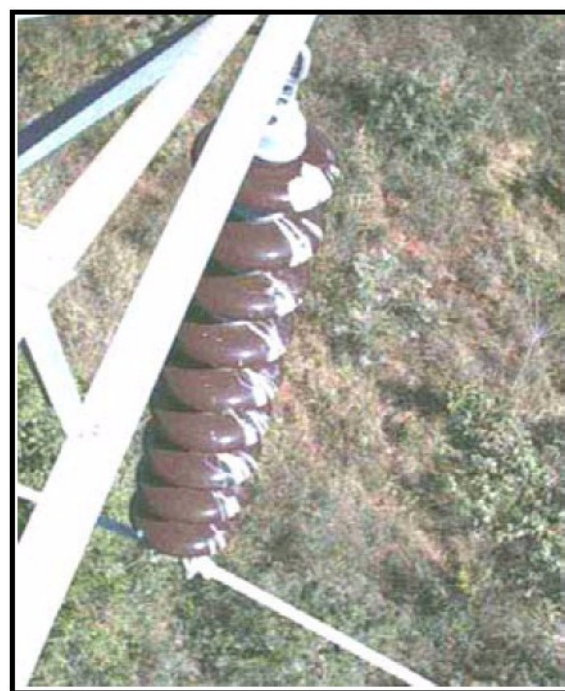
**Figure 4:** Curicaca's droppings on 138 kV TL insulator surface [5]

Due to the presence of bird droppings on some insulators, as seen in Figure 4 and 5, technicians have decided to substitute all the affected insulators by clean ones in aim to prevent outages related to pollution.

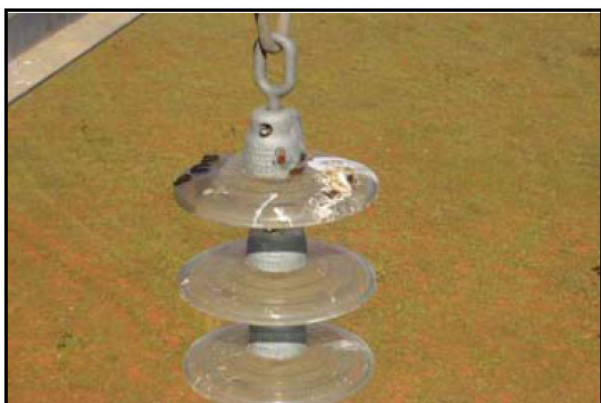
**Figure 5:** Curicaca's droppings on 69 kV TL insulator surface [5]

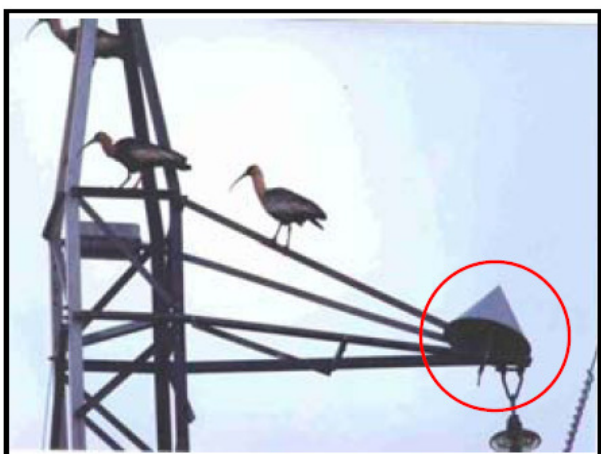
**Figure 6:** Perching guard cone type [5]

In all towers on which Curicacas have been observed, technicians have put perching guards in the position over insulator string, as showed in Figures 6 and 7.

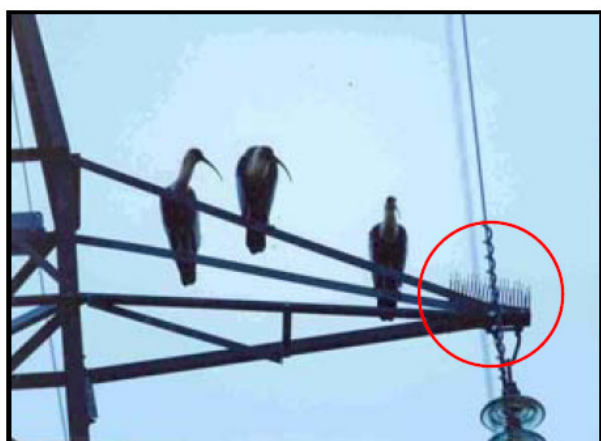
**Figure 7:** Perching guard needle type [5]

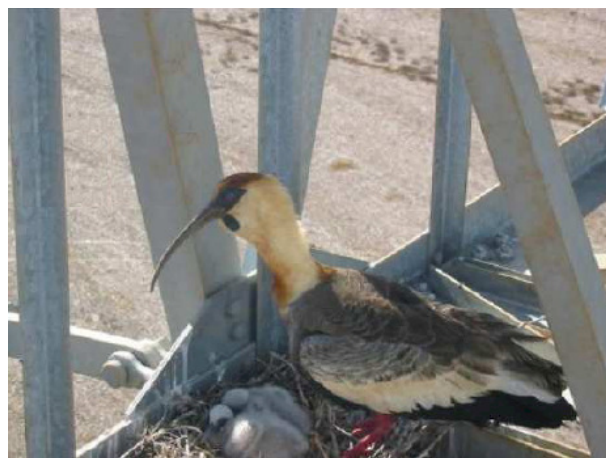
In a similar way technicians have looked for the causes and the investigations have lead them to identify the same issues: transitory outages during night and early morning, phase-to-ground flashovers and flashover marks at crossarms, conductors and fittings. In this case, all flashovers have occurred in the middle phase and along of entire lines.

During inspections they have confirmed the presence of Curicacas, as one can see in Figure 8, and have concluded that bird streamers were the cause of the outages.

**Figure 8:** Curicaca roosting on the 500 kV tower [6]

The solution adopted by technicians was to install perching guards in all 1287 towers of both TLs, after cleaning the crossarms.

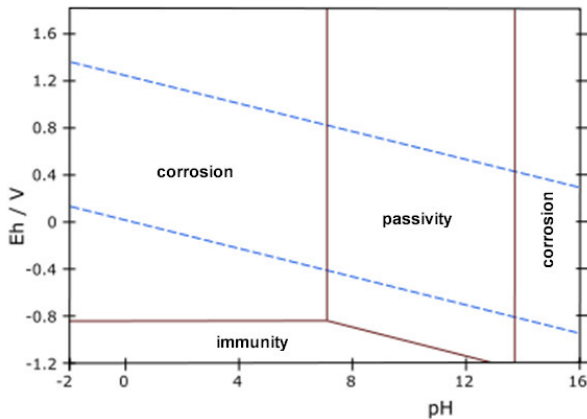
Figure 10 presents a simplified Zn Pourbaix diagram. This kind of diagram indicates the electric potential which characterizes the possible chemical reactions in function of pH value of the water solution. The region classified as passivity represents the one where corrosion process is negligible. In the Zn case it is between 7 and 14.

**Figure 10:** Zn Pourbaix diagram (adapted from [9])

Although the electric conductive values presented in Table 2 are significant the pH values around 7.5-8.5 indicate that Curicaca's droppings are non corrosive in this case.

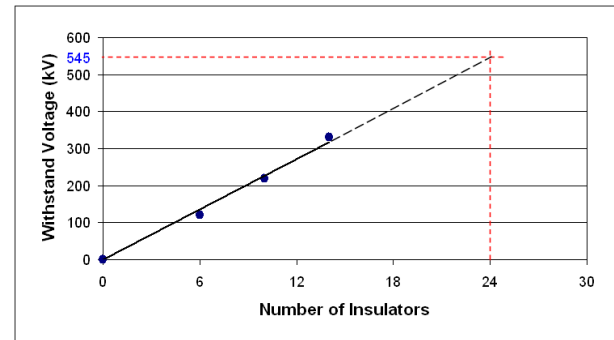
The determination of maximum withstand voltage to the entire leg of insulator string with 24 contaminated units was done by extrapolation, assuming the linearity mentioned above. Figure 11 indicates the value of 545 kV as this result. This

value is 80% greater than the maximum phase-to-ground voltage of the line.

**Figure 11:** Determination of maximum withstand voltage of 24 contaminated insulator string (one leg of the V configuration)

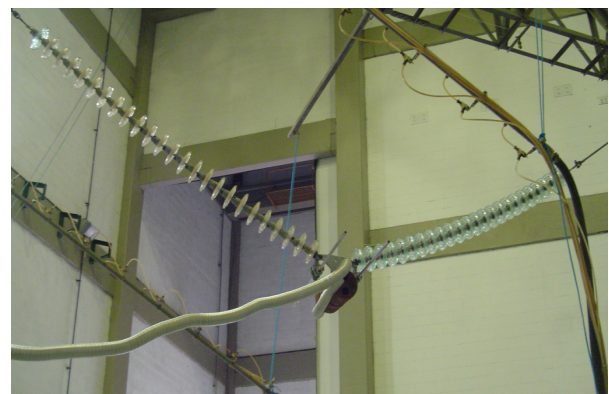
With the aim of verifying the electric behaviour of the naturally contaminated insulator string, one leg with 24 units removed from the field of the V configuration was submitted to the maximum withstand voltage calculated before under clean fog condition in the laboratory. Figure 12 shows the test arrangement. The left string is the naturally contaminated while the right one is kept cleaned. An additional insulator is included at the ground side to allow the measurement of the leakage current. The voltage was applied during 1 hour and no electrical activity was observed on the insulator string, confirming that the flashovers occurred in the field were due to bird streamers.

**Figure 12:** Test arrangement with the V configuration insulator string [7]
