## PARTIAL DISCHARGE PROBLEMS WITH TRANSFORMERS IN SERVICE: NEW PERSPECTIVES ON HYDROGEN AND MOISTURE

Matthias Boltze<sup>1\*</sup>, Hongzhi Ding<sup>2</sup> and Simon Ryder<sup>2</sup>

**Abstract:** Partial discharge is a leading cause of transformer failures both in works test and in service. Dissolved gas analysis is widely considered to be a useful tool for identifying developing partial discharge problems in large transformers in service. This paper examines some of the difficulties in using dissolved gas analysis, and other oil tests, to diagnose partial discharge problems. This paper also examines the role that high levels of moisture can have in causing partial discharge. It is concluded that high and variable levels of dissolved moisture and hydrogen can be an indication of serious problems, which can be investigated using off-line electrical condition assessment tests.

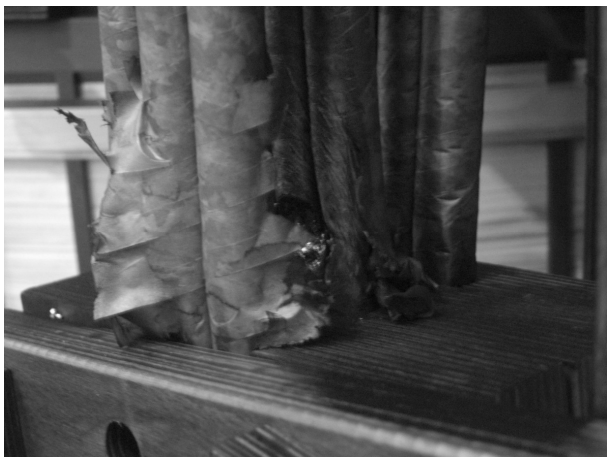
This case study concerns a 100MVA 132/11+11kV transformer at a large industrial plant. This transformer failed within an hour of first energisation, owing to a severe partial discharge fault in the 11kV connections. The cause of the partial discharge fault seems to have been a water leak from one of the openings for the 11kV bushings. It is not clear exactly when this took place.

Figure 1 shows the damage to the LV connections. A pool of free water seems to have collected on the upper surface of one of the cleats securing the LV leads. Evidence of free water was found at various other locations directly under this point.

**Figure 1:** Damaged LV Connections, case study 1

Various oil samples had been taken from the transformer – during works test, on filling, shortly before energisation and after failure. Levels of moisture were low – between 2ppm and 9ppm, with the highest level being during works test. Breakdown voltage results were good – 75kV or more in all cases.

This case study illustrates one important limitation in the use of oil tests to evaluate moisture levels in transformers. Unless the transformer is in thermal and moisture equilibrium, results can be misleading. In particular, free water can be present in transformers at low temperatures without this being detectable using oil samples.

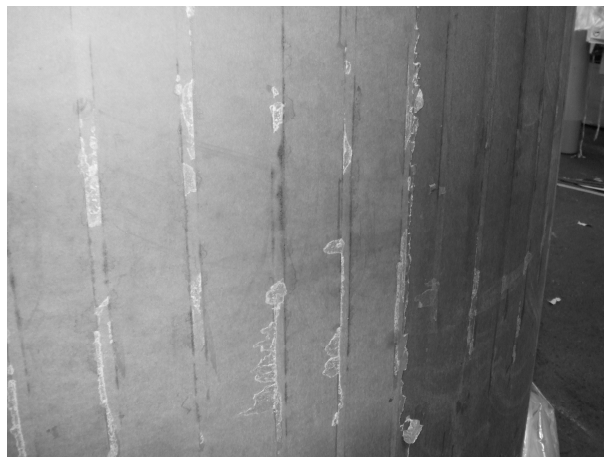
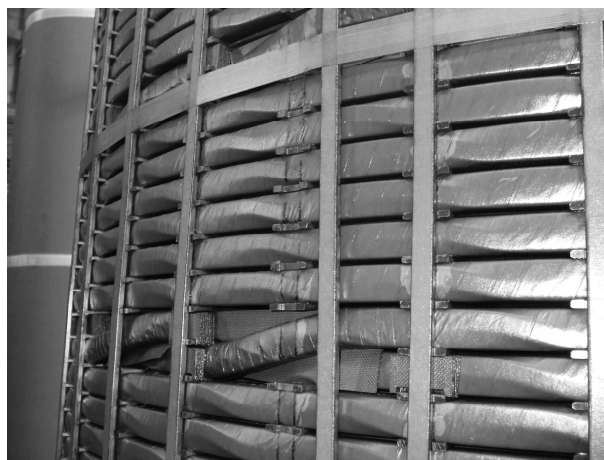
This case study concerns a 250MVA 400/110/20kV transmission transformer. This transformer failed after approximately four years' service, owing to a flash-over up the inside of one of the HV windings. The flash-over was the result of accumulated damage by partial discharge to the inter-winding insulation. Partial discharge damage was found on the oil-solid insulation interfaces in areas of high electrical stress throughout the transformer.

Figures 2 and 3 show some of the partial discharge damage to the solid insulation in the transformer. Note how it is concentrated along oil-solid insulation interfaces. The damage was very extensive, affecting all three phases and the end insulation as well as the inter-winding insulation. This suggests a cause affecting all of the insulation in the transformer, e.g. high levels of moisture.

Moisture in oil results had been rather high throughout the life of the transformer and had reached 24ppm at 8°C at about the time of failure. This would be equivalent to approximately 65% relative saturation and is a wholly unacceptable level of moisture in oil according to most widely used criteria [4, 5].

**Figure 2:** Partial Discharge Damage, case study 3

**Figure 3:** Partial Discharge Damage, case study 2

It is not completely clear how the oil came to be so wet. Possible explanations include incorrect filling on installation, poor breather function or water leaks in service. Some combination of the first two seems most likely.

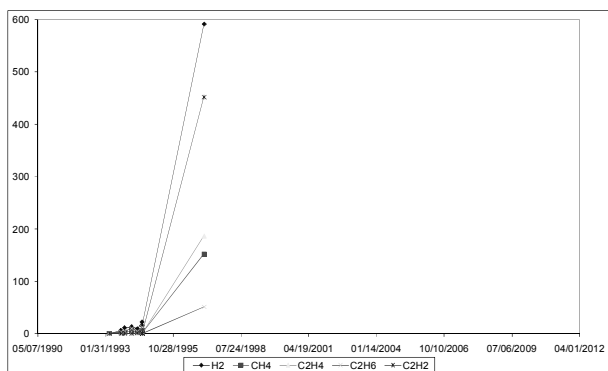
The transformer in case study 3 failed after approximately seven years' service, owing to severe partial discharge in part of the inter-winding insulation on one phase. Before failure it had a normal dissolved gas signature and normal levels of moisture in oil (maximum 20ppm).

The exact cause of the partial discharge was never found. The manufacturer believed that the cause was most likely micro contamination. The operator believed that the cause was most likely high moisture, making it similar to that for case study 2.

Figure 5 shows the dissolved gas history for the transformer in case study 3.

**Figure 4:** Dissolved Gas Results, case study 3

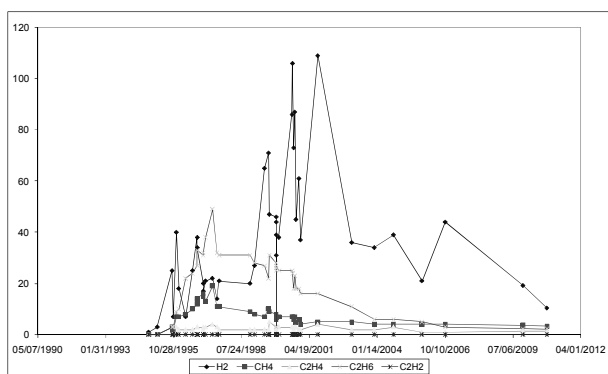
The transformer in case study 4 was manufactured around the same time as that in case study 3, and installed at a different location. For most of its life it has a rather different dissolved gas signature characterised by a higher level of hydrogen together with moderate levels of methane and ethane. The moisture level has been moderate (credible maximum 16ppm).

Figure 5 shows the dissolved gas history for the transformer in case study 4.

**Figure 5:** Dissolved Gas Results, case study 4

This case study is believed to be an example of so-called stray gassing. Many hydrogenated oils generate moderate amounts of hydrogen, methane and ethane under service conditions. The relative quantities of gas produced can vary over quite a range. It is thought to be influenced both by the exact type of oil used and the operating conditions.

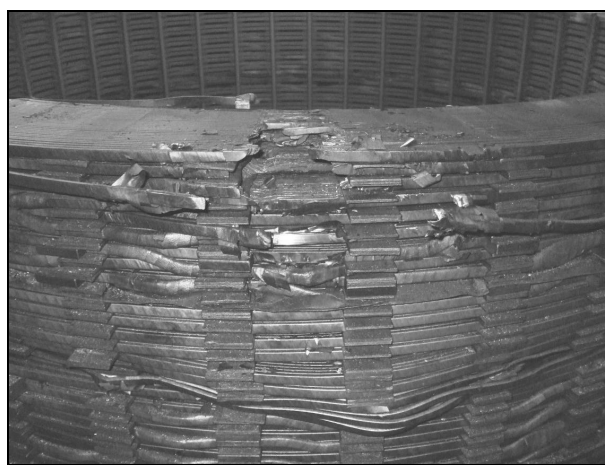
The transformer in case study 5 was built in the mid 1990s. It failed after approximately eleven years' service, owing to a combination of sulphur corrosion and severe solid insulation ageing in part of the series winding. The failure is discussed in more detail in [7].

Figure 6 shows some of the damage to the series winding. Before failure there had been indications of some stray gassing, which seemed to be reducing.

**Figure 6:** Damage to Series Winding, case study 5

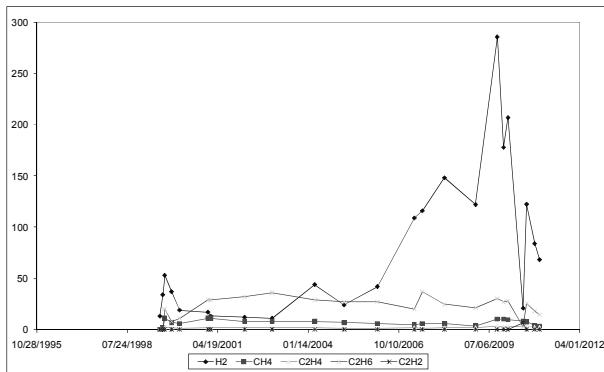
Figure 7 shows the dissolved gas history for the transformer in case study 6. Note the renewed stray gassing after the passivator was added. In this case hydrogen was produced, but no other gases. Experience suggests that this experience is typical in transformers with free-breathing oil preservation systems. Methane, ethane and carbon oxides are produced in some cases, especially in transformers with sealed oil preservation systems [9]. Where only hydrogen is produced the dissolved gas signature is difficult to distinguish from that of partial discharge.

**Figure 7: Dissolved Gas Results, case study 6**

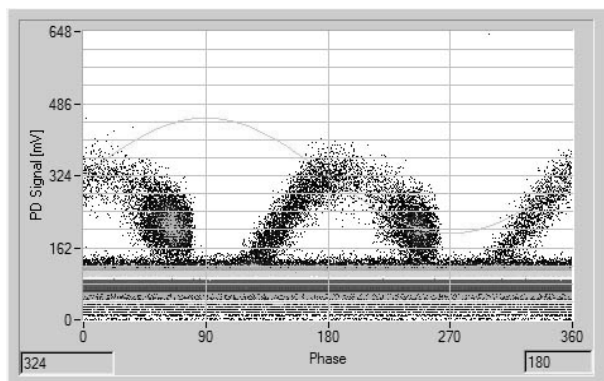
A UHF partial discharge sensor was fitted to each of the transformers to determine whether the high hydrogen level in the first transformer was indeed caused by partial discharge. With the UHF sensor fitted, each transformer was returned to service and monitored for partial discharge. Significant levels of partial discharge were found in the first transformer (case study 7), but not the second (case study 8).

Figure 8 shows the phase-resolved partial discharge patterns measured on the transformer in case study 8

**Figure 8: Phase-Resolved Partial Discharge Pattern, case study 8**

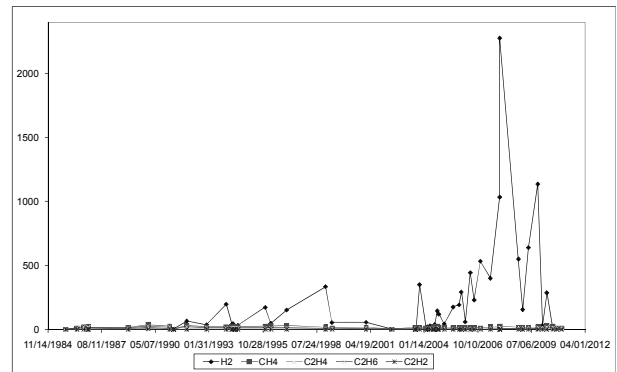
These case studies concern two identical 240MVA 400/132/13kV autotransformers. These were built in the mid 1980s and installed at the same location. Their dissolved gas signature has been characterised by variable and frequently very high levels of hydrogen. Levels of moisture have also been high variable and frequently very high e.g. 73ppm for the transformer in case study 9 and 158ppm for the transformer in case study 10.

**Figure 9: Dissolved Gas Results, case study 9**

Figure 9 shows the dissolved gas history for the transformer in case study 9.

It had been thought that the hydrogen in these two transformers was being produced by a chemical reaction, probably involving moisture, especially as attempts on both transformers to measure partial discharge in service using the UHF method proved unsuccessful. Indeed, there are a number of reports in the literature of hydrogen being produced in this way, e.g. [13, 14, 15].

The higher main winding – tertiary power factor for the transformers in case studies 9 and 10 is a clear indication of worse dielectric condition. It is believed that high levels of moisture are leading to intermittent partial discharge, in a manner similar to case study 2 and perhaps also case study 3. This case study illustrates the value of off-line electrical condition assessment testing for suspect transformers.
