## LEARNING FROM FAILURES IN RISK-BASED TRANSFORMER ASSET MANAGEMENT

Hongzhi Ding\*, Richard Heywood, John Lapworth and Simon Ryder  
Doble PowerTest Ltd, United Kingdom

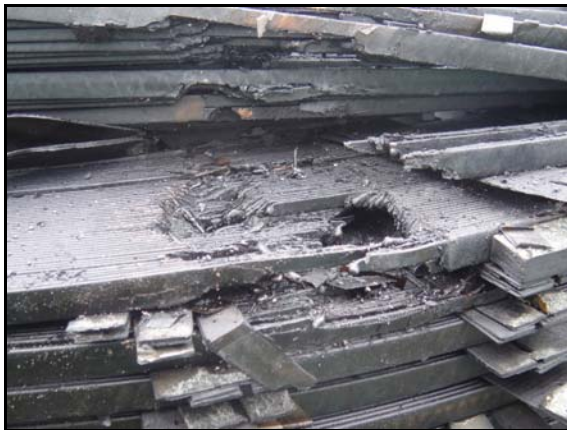
During the scrapping, the shorted turns in the 2<sup>nd</sup> and 3<sup>rd</sup> discs of series winding was found as shown in Figure 1. There was extensive loss of conductor and conductor insulation in the upper part of the series winding. The worst degree of polymerisation (DP) measurement obtained was approx 144 from the middle strand of top disc of the middle phase series winding. The next worst result was approx 156 from the middle strand of top disc of A/red phase series winding. The DP results on paper samples showed that apparently the insulation condition of the series winding had reached the end of its life.

The learning point from this case study is that the short turn was developed as a result of severe winding conductor insulation ageing which was partly a function of the age of the transformer and the loading to which it had been subjected. The poor thermal design of the series winding, however, led to localised overheating of certain areas, including the point of failure.

Figure 1 Failure of transformer by shorted turns

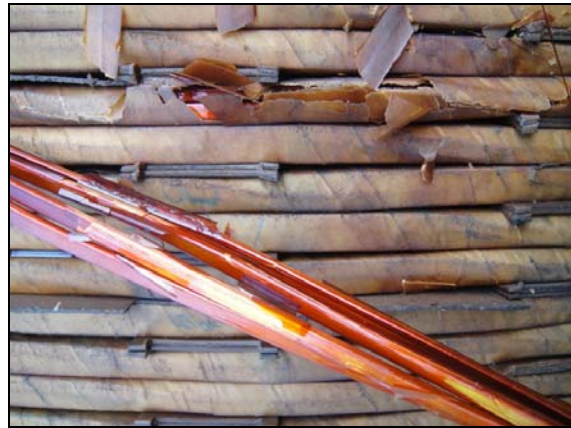
During the scrapping, visual examination revealed severe paper ageing on the LV winding. As shown in Figure 2, some of the LV winding close to the top end had paper which was dark brown in colour and appeared to have experienced severe

overheating. The worst DP result was approx 185 which confirmed that the insulation of the LV winding had reached the end of its life.

The learning point from this teardown investigation was the discovery of the well-developed winding hotspots which is typical end-of-life scenario. The transformer although did not fail when it was decommissioned would have been at increased risk of failure from switching impulses and short circuits if it was returned back to service.

Figure 2 Developed hotspots on LV winding

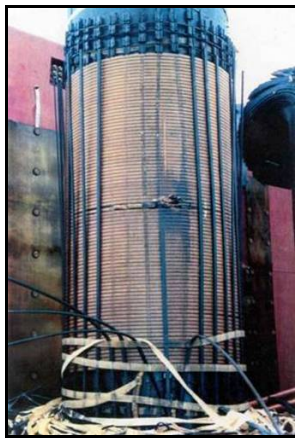
After the return to service this transformer subsequently survived high loading in January 1996 without obvious signs of fault deterioration. But in April/May there were signs of increased gassing in the main tank, and the transformer was removed from service permanently. The subsequent teardown inspection revealed the cause of the two incidents. As shown in Figure 3,

the inter-strand insulation at a transposition joint at the midpoint of the innermost LV winding was badly damaged and it would have been impractical to repair the transformer at site.

Figure 3 LV winding fault caused by overheating

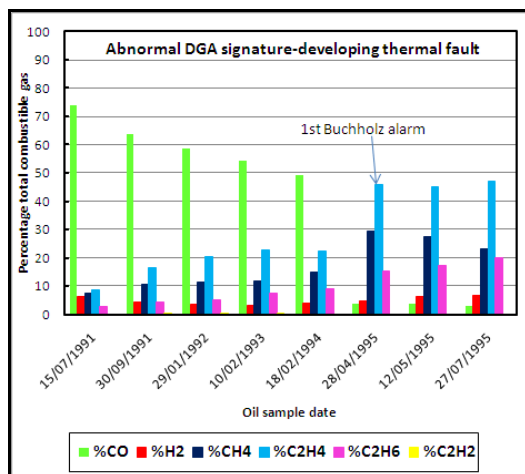
So when did this thermal fault start? Figure 4 shows the abnormal DGA signature, indicating that the developing thermal fault should have been identified between 1991 and 1994 (i.e. years before the first Buchholz alarm at the end of April 1995) and unit put on a risk list for investigation and life management.

Figure 4 Abnormal DGA signatures

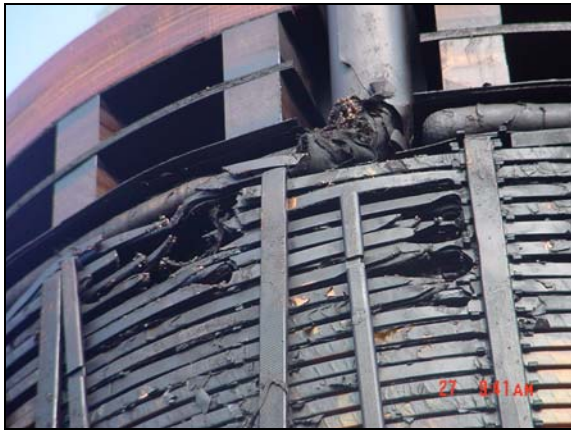
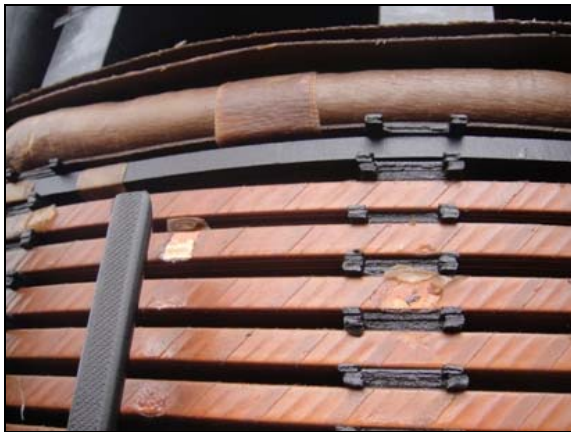
In 2001 a member of this population which was used to supply a steel works with arc melting furnaces failed suddenly. Electrical testing after failure showed signs of short-circuited turns. It is believed that the repeated impact loading from supplying the arc furnaces caused the winding clamping to loosen, allowing localised LV winding movement, fretting, loss of conductor insulation and eventually turn-to-turn failure. The failed transformer was replaced by another of the same design, which failed itself after approximately one years' service at its new location. Investigations showed that the second failure was very similar to the first, as shown in Figure 5 (up).

When they were removed from service in 2010 as a planned replacement after 40 years in service and after they had suffered suspected LV winding movement for 5 years, a detailed teardown examination of the windings revealed evidence of mechanical damage to the LV windings, including broken conductor insulation in the upper part of R and B phases, as shown in Figure 5 (down). These findings confirmed that the condition assessment, in particular the interpretation of abnormal winding frequency response measurements in 2005, was correct and the transformer was indeed approaching the end of its life.

From the teardown inspection, it was noted that three design weaknesses that may have made the transformer more prone to mechanical damage to the LV windings. These were inadequate placing of

vertical spacers, inadequate mechanical stability and undesirable clamping arrangement.

Figure 5 Understanding the implication of increasing risk of failure: LV winding failure in 2002 (up) and LV winding mechanical damage found in sister unit in April 2010 (down)
