ELECTRICAL PERFORMANCE AND POLLUTION ANALYSIS OF IN-SERVICE HVDC GLASS DISCS

T. Govender^{1*}, N. Mahatho¹, N. Parus¹, E. Greyling¹ and H. A. Roets²

¹Eskom Holdings SOC Ltd, Johannesburg, South Africa

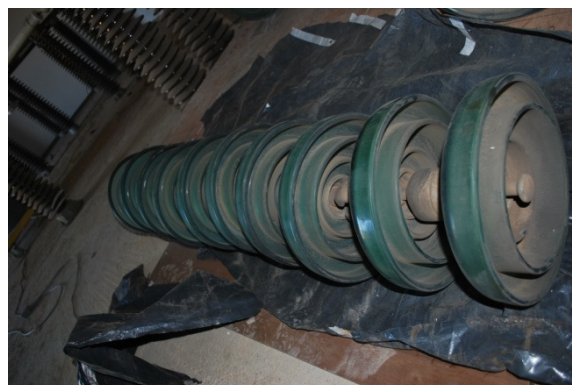
Figure 1: Removed insulator strings - Tower 122.

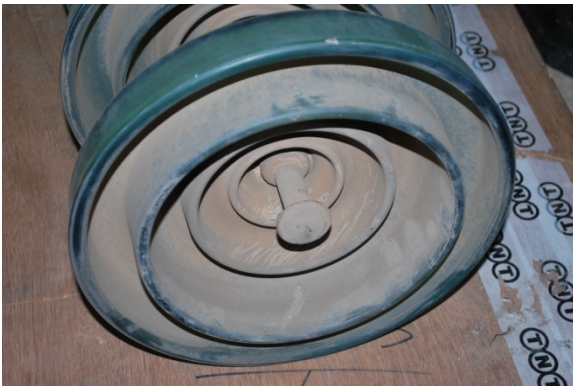
Figure 2: Removed insulator strings - Tower 119.

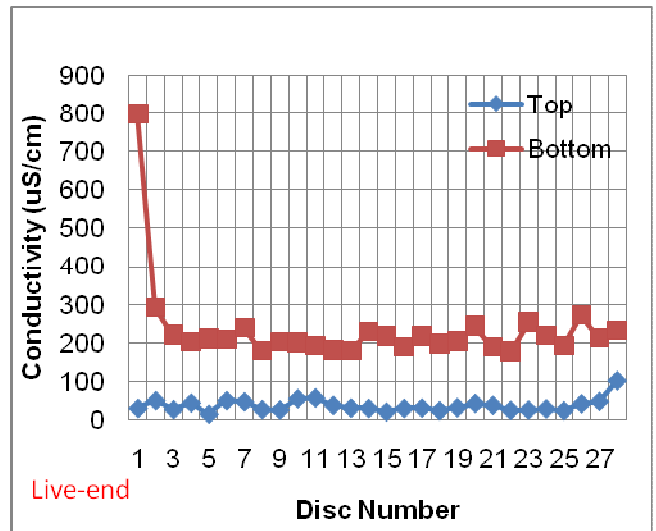
It can be seen from Figure 4 and Figure 5 that the bottom surface has a consistently higher level of pollution accumulation than the top surface. This is expected given the electrostatic catch mechanism associated with HVDC lines [3] combined with the top surfaces being exposed to greater washing from rain and cleaning by wind.

Figure 4: Measured conductivity - Tower 119.

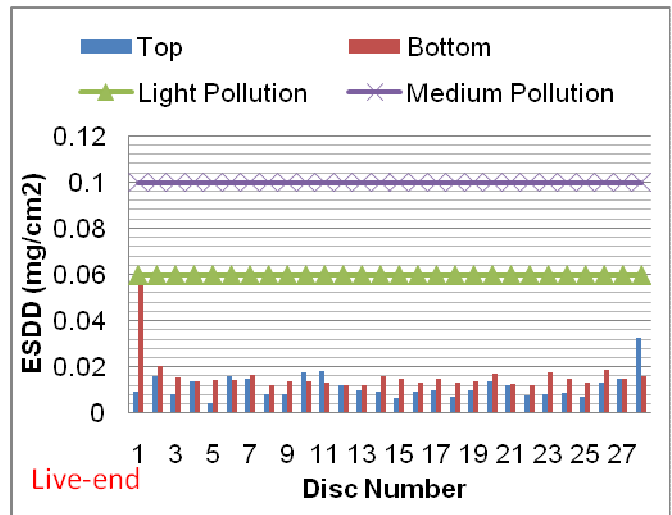
The highest ESDD value recorded places the string in the light pollution severity class according to IEC 60815-1 [2].

Figure 5: Calculated ESDD values - Tower 119.

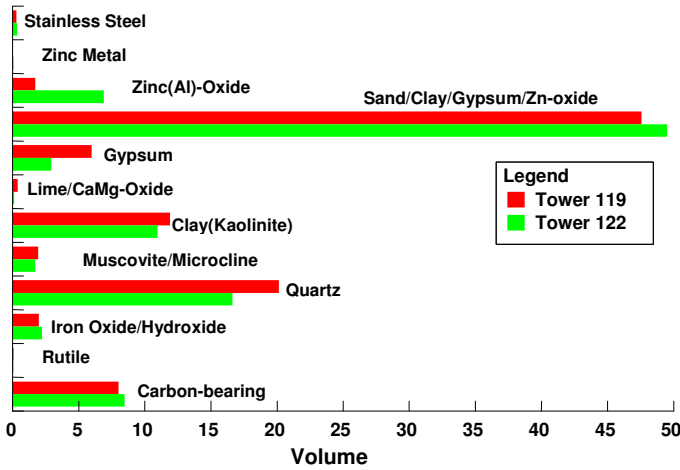
The major constituents in the two samples were identified to be Zn(Al)-oxide, quartz (SiO_2 , sand), kaolinite ($\text{Al}_2\text{Si}_2\text{O}_5(\text{OH})_4$, clay), gypsum/anhydrite ($\text{CaSO}_4 \cdot 2\text{H}_2\text{O}$, "scale") and mica (muscovite). The results of the constituency analysis are shown in Figure 6. Figure 7 illustrates the particle size distribution for Tower 119 and Tower 122.

Figure 6: Predicted mineralogical proportions by percentage volume[4].

The deposits on the insulators strings consisted of a fine mixture of quartz (sand), kaolinite (clay), gypsum and Zinc (Al)-oxide. The gypsum will cement these fine particles into a hard deposit resistant to rain and wind. Gypsum is a by-product of lime reacting with sulphuric acid. The source of the lime is most likely to be the cement used in the production of bricks. If the brick manufacturing process is coal fired, SO₂ produced can react with moisture in the air to produce the required acid necessary for the formation of gypsum and the hard deposit seen.

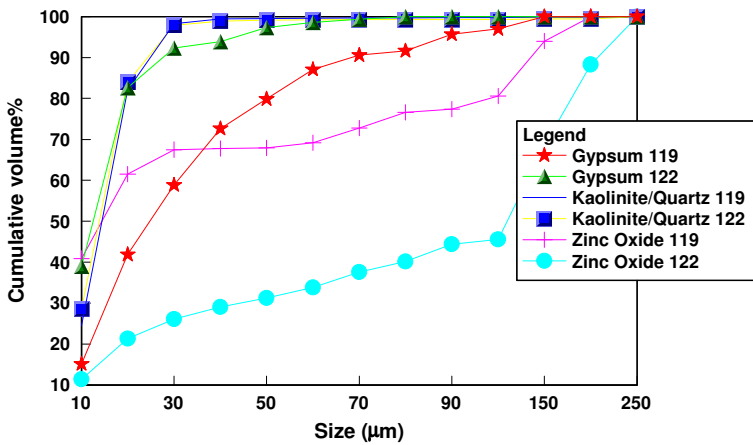
Figure 7: Combined Particle size distribution for Tower 119 and Tower 122 [4].

Between Tower 119 which was in close proximity to the brick manufacturing facility and Tower 122, a few hundred meters away, there is no discrimination between the size distribution of kaolinite/quartz. The particle size range is within that of typical air borne dust. Tower 119 yielded a higher proportion of gypsum as well as a higher proportion of coarser gypsum relative to tower 122.

The similar size distribution of kaolinite/quartz and gypsum seen on Tower 122 suggest that a higher proportion of lime/gypsum in the pollution sample of Tower 122 was wind borne. The coarser distribution of lime/gypsum in the pollution sample of Tower 119 suggests that a proportion of the sample can be directly attributed to activity within the brick manufacturing facility.

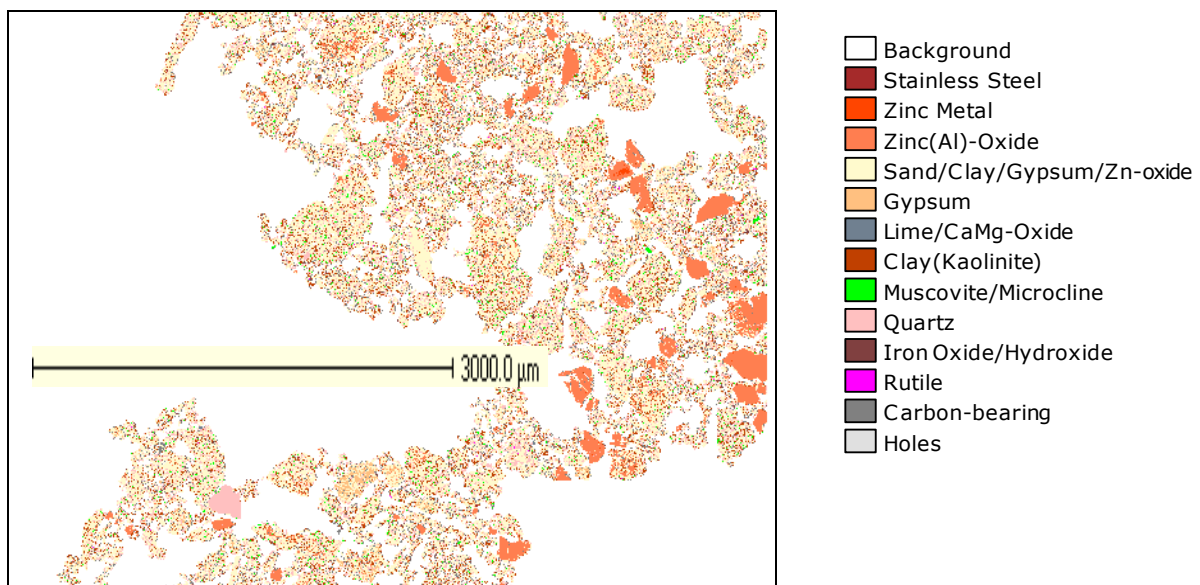
Figure 8 is a QEMSCAN false colour image of the deposits on Tower 122 [4]. The larger particle size distribution and angular nature of the zinc oxide fragments seen supports the theory that the zinc oxide fragments are the remnants of oxidation of the galvanized metal parts of the insulator disc. Sulphuric acid attack could initiate the oxidation of the galvanizing layer.

Figure 8: QEMSCAN false colour image of Tower 122 deposits. Note coarse Zinc-oxide - metal fragments.

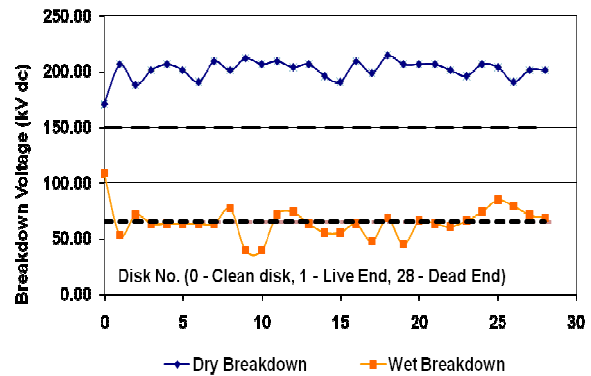
Figure 11: Lowest obtained flashover values for Tower 119.

From Figure 11 and Figure 12 it can be seen that for most cases the polluted discs perform at or better than their clean, rated values. This is expected given their light pollution severity classification.

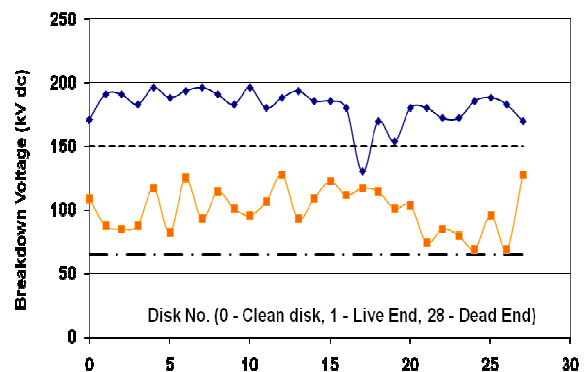
Figure 12: Lowest obtained flashover values for Tower 122.

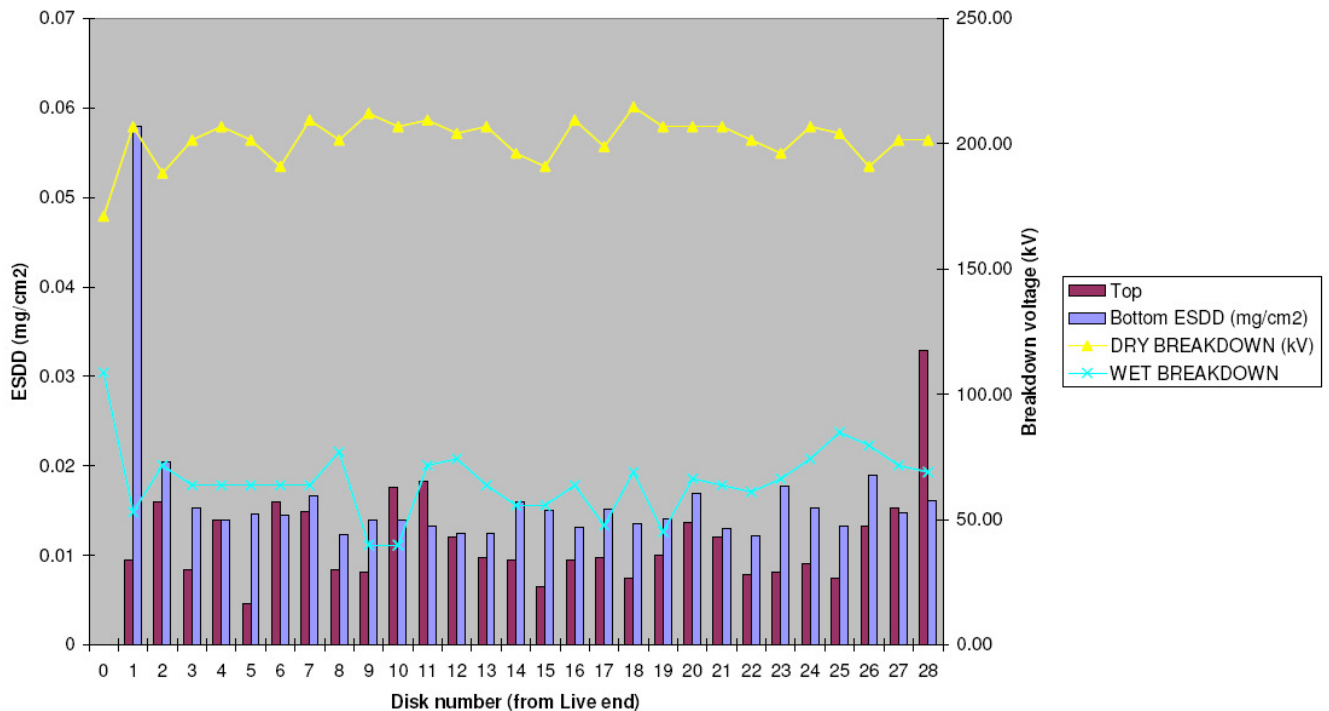
Figure 13 is of the flashover variation with the calculated ESDD values across the Tower 119 insulator string. There appears to be little correlation between ESDD value and flashover value for the pollution class investigated.

Figure 13: ESDD and flashover variation across insulator string from Tower 119.
