OUTDOOR INSULATORS AND HOUSINGS BREAKDOWNS CAUSED BY POLLUTION

Abstract: A heavy pollution on outdoor insulators causes electrical discharges, flashovers, surface erosion or tracking. In extremely cases the dielectric breakdowns occur. In this paper the breakdowns of four insulators has been shown: porcelain bushing insulators on rectifier set ups of electrostatic precipitators, the porcelain fuse cutouts, a porcelain housing of metal oxide surge arrester and polymer concrete insulators. The analysis of other damages of condenser bushings and instrument transformers published in the literature has led us to a hypothesis that a part of these failures could be initiated or accelerated by external pollution.

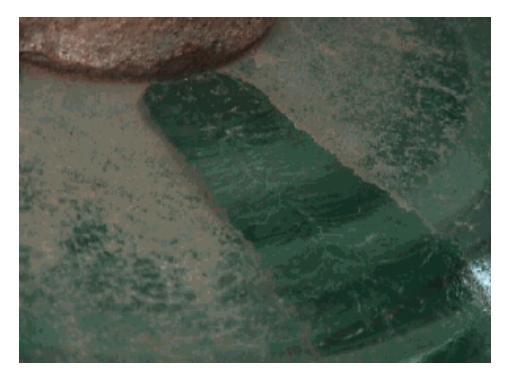
Figure 1: Erosion of Glass insulators in coastal area [1].

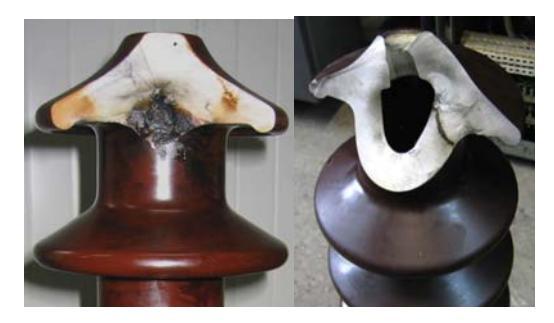
The frequently insulator damages in the form of porcelain puncture or cracks are caused by intensive discharges on polluted surface. The transformers are located under an umbrella roof, thus the wetting by rain droplets is impossible. Additionally, to decrease the contamination, a metal stall was build around the bushings. The air is pumped to the metal stalls under small overpressure. Unfortunately, even so complicated measures did not come to be helpful. Therefore, since over 10 years the insulators are cleaned every 2 weeks and covered by a hydrophobic paste. In spite of these all mitigation options the breakdowns still occur especially at the top shed. Two such cases are shown in Figure 2 The visible black channel suggests the thermal breakdown.

Figure 2: Typical breakdowns at the top shed [2]

Porcelain bushings DT 30NF/630 have the leakage distance of 64 cm, on the other hand the DC operating voltage reaches sometimes the value of 70 kV. It means that the specific leakage distance is very short, about 0,9 cm/kV. For DC outdoor insulators the specific leakage distance should be longer than 3 cm/kV (pollution level light) or even 7 cm/kV (pollution level very heavy). The operation of insulators with so short leakage distance under heavy pollution is here possible because they work indoors with a very small wetting rate.

The pollution layer absorbs water from humid air [3]. Therefore, electrical discharges can burn on insulators under indoor conditions. The dry band forms usually at the insulator top because there is a higher temperature and the greater current density (smaller diameter) there. If the pollution layer in the middle and bottom part of insulator is sufficiently wet, then the discharges on the top can ignite.

The transformer cage and bushing insulator are filled with oil. Unfortunately, some gas volume can be collected inside the bushing top due to oil gassing. The dry band at the top causes a radial field stress because the wet part of pollution layer moves up the ground potential. As a result, internal partial discharges, high temperature and radial field stress can lead to porcelain breakdown.

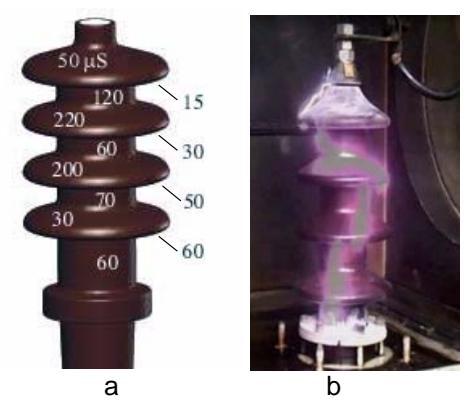
The surface conductivity measurements by means of strip probe revealed the surprisingly high values in the range of 200 μ S (Figure 3a). The pollution layer was very thin and had acidic character pH = 2. After voltage application the very intensive discharges developed up to the flashover (Figure 3b).

Figure 3: Results of surface conductivity measurements in μ S (a) and intensive discharges after voltage application on bushing insulator (b).

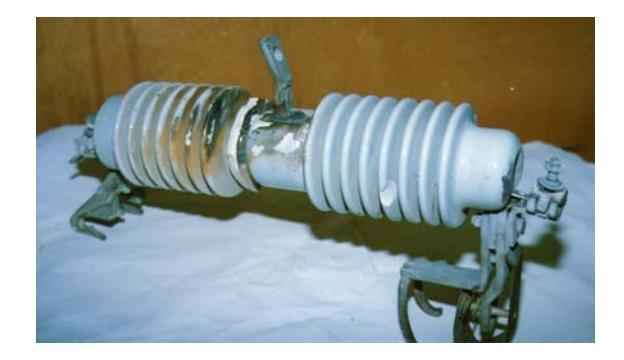
The Tunisia environment is dominated by Desert, marine and industrial pollution with the high or very high pollution levels. The ESDD and NSDD maximum values are in the range of 0,6 mg/cm² and 1,3 mg/cm² respectively. The unexpected salt proportion in the sand is relatively very high and may contain up to 18% salt. Almost all destroyed fuse cutouts were installed on the 33 kV earthed systems (17,5 kV phase-earth) along the coast and close to industrial and desert areas (Figure. 4). The creepage distance is in the range of 800 mm corresponding to the new standardized USCD of 46 mm/kV. This design of fuse cutout , especially with regular sheds and short spacing distance, is not suitable to such specific pollution environment with dominant solid layer heavy deposit.

As elsewhere in many countries in Middle East & Northern Africa, the pollution performance of outdoor insulation is mainly influenced by their material, their position in service, their shed profile, inclination and configuration. Consequently, the design geometry in general, and the self cleaning ability in particular of fuse cutout should be considered as one of the main selection criteria of external insulation than the sole creepage distance.

Figure 4: Typical Failure of 33 kV fuse cutout in coastal areas in Tunisia.

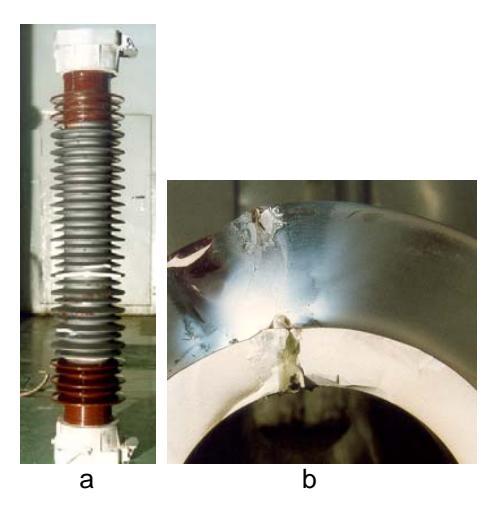
The varistor temperature of metal oxide surge arresters increases under pollution conditions. This thermal behaviour is especially important for multiunit arresters. Additionally, due to a high radial field stress, the internal partial discharges could damage Zno varistors. Some special laboratory tests (radial field test or internal arcing test) were proposed to check the resistance of varistors and arrester to this pollution influence [4]. Internal arcing test model the critical conditions by formation of single artificial dry band representing approximately 10% of the leakage path. During testing of 110 kV surge arrester the 30 mm thick porcelain housing was punctured (Figure 5). The varistor temperature exceeded 160°C. This damage could be caused by a manufacture fault because such breakdown never occurred during many similar tests of surge arresters produced by other company.

Figure 5: The damaged surge arrester during an internal arcing test (a) and the breakdown trace in porcelain (b) [5].

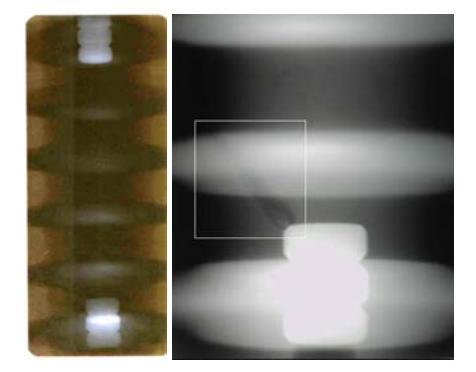
Three insulators were damaged by breakdown of dielectric material from the surface to the inserted metal parts. Figure 7 shows the breakdown channel as the diagonal of the marked square. These test have shown that polymer concrete insulators can be used in clean pollution site on 20 kV lines. However, the application on 110 kV lines could be risky even in clean pollution site. The experiences with PC insulators in USA in clean conditions is positive and bad in heavily polluted sites in Mexico and Great Britain [6].

Figure 7: Roentgen pictures of insulators with metallic inserts and breakdown channel.

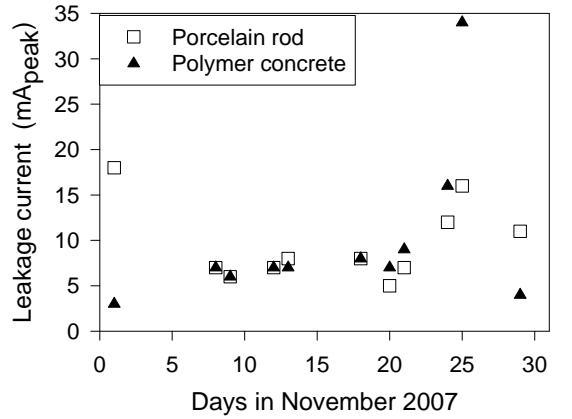
The daily maximum currents measured in November 2007 on the string of 3 PC insulators (leakage distance of 156 cm) and on porcelain rod with the diameter of 3 cm and leakage distance of 105 cm are shown in Figure 8. The maximum current value on PC insulator was 34 mA. The maximum current on porcelain rod found on the same day was two times lower. However, the opposite relation was noted on November, 1. The maximum current value of 18 mA occurred on porcelain rod and only 3 mA on PC insulator.

Figure 8: Leakage currents on polymer concrete insulator and on porcelain rod measured at Glogow test station in November 2007.
