## INFLUENCE OF AIR-BORNE VOLCANO ASHES ON OUTDOOR INSULATION

**Abstract:** The 2010 eruption of Eyjafjallajökull volcano in Iceland caused enormous disruption to air travel across western and northern Europe. At the same time power companies in Scandinavia were worried that in the worst case one should be prepared for washing of some insulators in overhead lines and substations. A comprehensive investigation using a collection of existing experience and laboratory testing of samples of volcano ashes from Eyjafjallajökull volcano was performed for evaluation of possible influence of ashes on the dielectric strength of polluted outdoor insulation including glass/porcelain and silicone rubber insulators. Criteria for critical pollution levels of ashes were established and compared with typical dimensioning criteria for Scandinavian overhead lines. No issues for polluted outdoor insulation were expected for Norway and Sweden during the eruption in Iceland. However, insulation may be affected in the vicinity of a volcano.

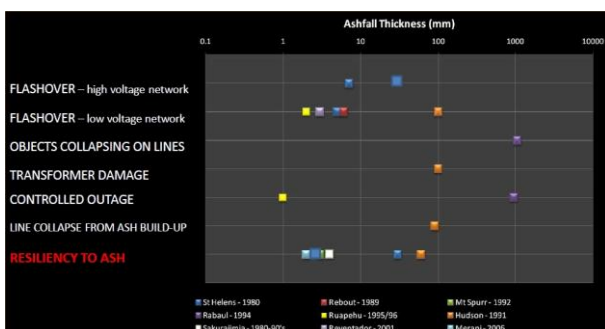
**Figure 4:** Evaluation of risk for flashover depending on ash fall thickness (adopted from [3]).

It is clearly seen that the thickness of ashes have to be higher than a few mm to create insulation troubles.

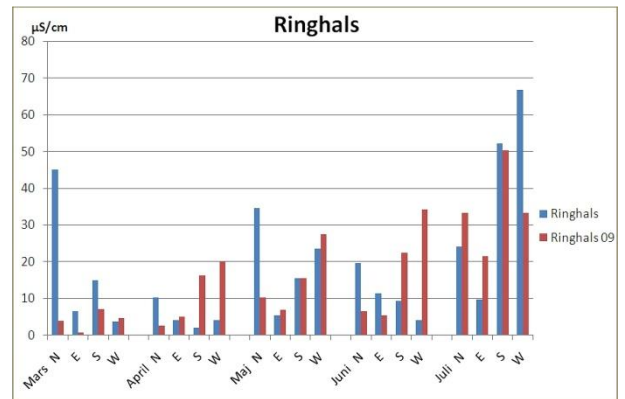
**Figure 8:** DDDG measurements at Ringhals (red colour in 2009; blue colour in 2010).

Ringhals site is located very close to the sea. The Horred measurement station is located more inland (about 10-15 km) and therefore is not affected by the pollution from the sea to the same extent as Ringhals. It is important to note that the data presented in Figure 8-Figure 9 as March 2010 was actually collected on the 20th of April 2010, for both measurement stations. Thus this is the data most relevant for the evaluation of volcano influence. The DDDG measurement devices are constructed as four tubes and thus pollution is captured from four directions, namely: North, South, West and East. At the Ringhals graph one can see an increase in March 2010 from the Northerly direction. This is very important since the sea is located to the North and West of the measurement station. One can also see that in May 2010 there is another increase from the Northern direction and in July 2010 there is an increase from the Westerly direction. The peaks in May and July cannot be connected to the eruption of Eyafjallajökull. Even though Iceland is also located North West from the measurement sites these later increase in pollution accumulation can be most probably attributed to the pollution transport from the sea.

Another confirmation of this conclusion is that during the months of March 2010 and May 2010

there are no increases in the pollution measurements from the northerly and westerly directions at the Horred measurement site. Also, the level of Horred DDDG is constantly lower than for Ringhals. If the pollution from the volcano travelled hundreds of kilometers, this would almost equally influence both of measurement sites, which are located rather close. Instead, some increase was observed only at Ringhals site confirming that this increase in pollution can be attributed to pollution carried from the sea, since the Horred station is located further inland and is not directly on the coast. Thus, no increase of conductive part of pollution captured from the air was observed at the West coast of Sweden during the peak of eruption in April 2010.

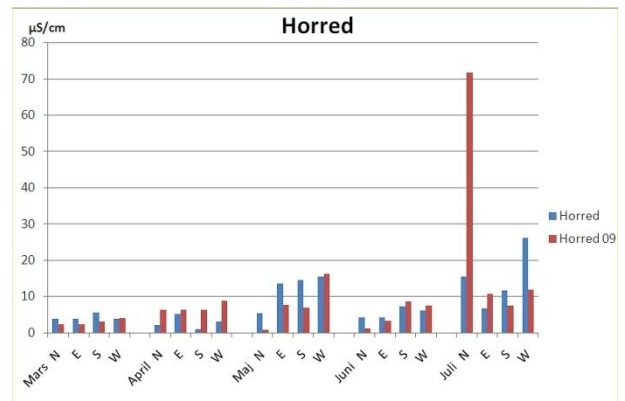
**Figure 9:** DDDG measurements at Horred (red colour in 2009; blue colour in 2010).

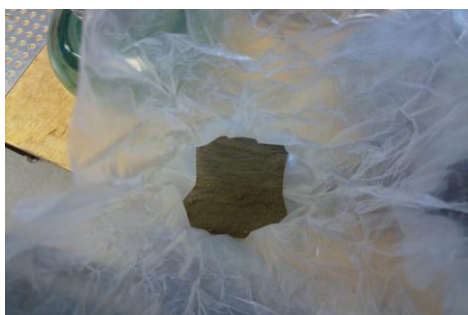
Figure 10: Ash sample 1, collected in April 2010.

Two different ash samples were tested. These samples were taken from the same location in Iceland (the Seljavellir farm approximately 8 km from the Eyjafjallajökull volcano crater), but at different times. Ash sample 1 was taken on the 24<sup>th</sup> of April 2010 and ash sample 2 was taken on the 15<sup>th</sup> of May of the same year. Since the eruption started in April it is assumed that ash sample 1 contains ashes taken immediately after the eruption and ash sample 2 contains ashes taken some time after the eruption. These two samples are clearly different visually (even in colour) see Figure 10-Figure 11.

Ash sample 1 is "sandier" in nature; it is very dry and appears to have finer particles. Ash sample 2 is more clay-like and appears to contain some moisture; it seems to be heavier and contains bigger particles. The density of ash sample 1 was 1,5 g/cm<sup>3</sup> and the density of ash sample 2 was 1,2 g/cm<sup>3</sup>. This difference may be explained by a larger volume of air bubbles inside ash sample 2 with larger particles.

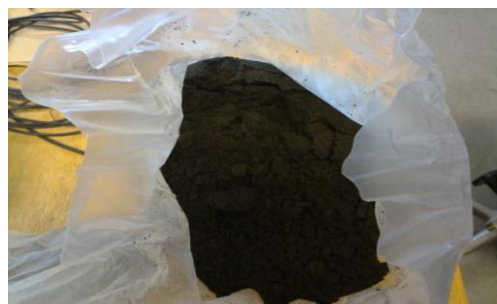
Figure 11: Ash sample 2, collected in May 2010

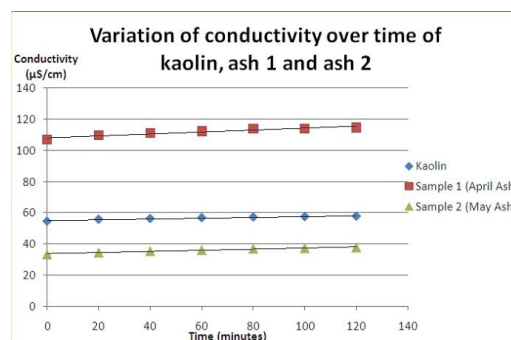
Figure 12: Conductivity of kaolin and ash sample solutions over 120 minutes.

The goal of this part of the report was to evaluate possible contribution of volcano ashes in standard pollution severity parameter Equivalent Salt Deposit Density (ESDD) defined by IEC 60815-1. In comparison with two samples of ashes kaolin was used. This is standard neutral (almost non-conductive) pollutant used for artificial pollution tests according to IEC 60507. The first step consisted of mixing the kaolin and distilled water in order to get a solution of 40 g/l of kaolin and measure its conductivity. This is a standard solution prescribed by IEC 60507. The conductivity of each of the three solutions was measured at 20 minute intervals over a period of 120 minutes. The results are shown in Figure 12. The obtained results are summarized as follows. "Fresh" samples of ashes (sample 1) are about two times more conductive than kaolin. This is, however, still an indication of low conductivity, because kaolin is a neutral (non-conductive) material specially used for this purpose in standard artificial pollution tests. "Aged" samples of ashes (sample 2) are characterized by lower conductivity than sample 1 and even kaolin. Possible explanation is that salts are partially washed away from this sample. In general, ashes are characterized by low soluble salts, which may give an increase of about 30% in conductivity after 24 hours (was specially checked). The process of dissolving seems to be saturated at this stage.

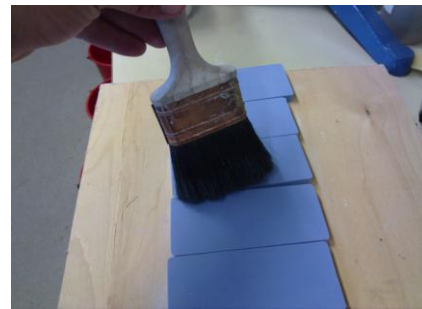
**Figure 13:** Pre-conditioning of the silicone rubber samples.

The tests were performed on plates of “standard” High Temperature Vulcanized (HTV) silicone rubber; the same plates were used in [7]. Firstly the slurry was prepared with some salt with the aim of producing an ESDD of 0,1 mg/cm<sup>2</sup> when polluting a silicone rubber sample. The silicone rubber plates were firstly pre-conditioned; a brush was used to apply dry kaolin powder to the plates, see Figure 13. Four silicone rubber plates were then polluted using each of volcanic ash sample as well as kaolin. The resistance across the plate in time during gentle spraying was then calculated. This was done by applying the voltage 500 V across the plate and measuring the leakage
