SPECIAL HEAT CYCLE VOLTAGE TEST of 275kV XLPE CABLE SYSTEM

Harris Heo¹, CS Go¹, Rakeun Choi¹, Jiho Kim¹, Nicola Moffa², George Bucea²

¹ LS Cable & System, Republic of Korea, ² ElectraNet, Australia

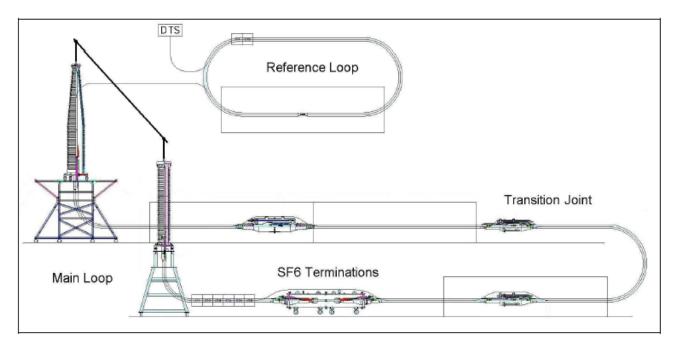
Fig. 1 Test Assembly - Main and Reference Cable Loops

The test assembly layout comprised two components (i) the main loop which included all cable circuit main components and (ii) the reference cable loop as shown in Fig. 1.

The main loop was set by jointing in series the 5 (five) cable sections and cable accessories. An aerial busbar connector between the two outdoor terminations closed the loop and connected the main loop to the HV test source.

The reference loop comprised a closed loop of cable only, with some installed in air and some direct buried. No voltage was applied to this loop.

Conductor heating was achieved by inducing a loop current using several current transformers placed on each cable loop and controlled by an automated system.

The reference loop current and conductor and sheath temperatures were measured and used to control the induced current required in the main loop to achieve the required heating cycle temperature profile.

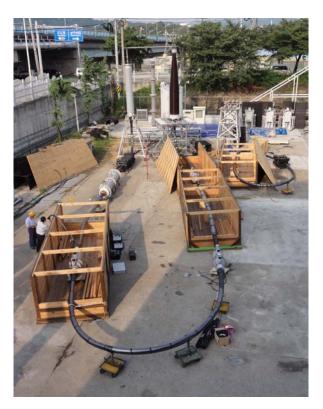
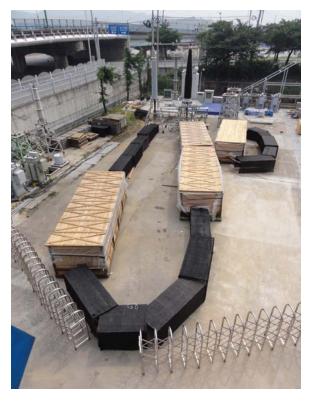
Fig. 2 Test Assembly – Assembled and After Filling with Sand and Fitment of Covers

Direct buried conditions were simulated by burying the cable and joints in sand-filled boxes (Refer to Fig. 2).
