## ON-SITE REFURBISHMENT AND HV TESTS OF LARGE POWER TRANSFORMERS IN THE HUNGARIAN TRANSMISSION GRID

### Abstract:

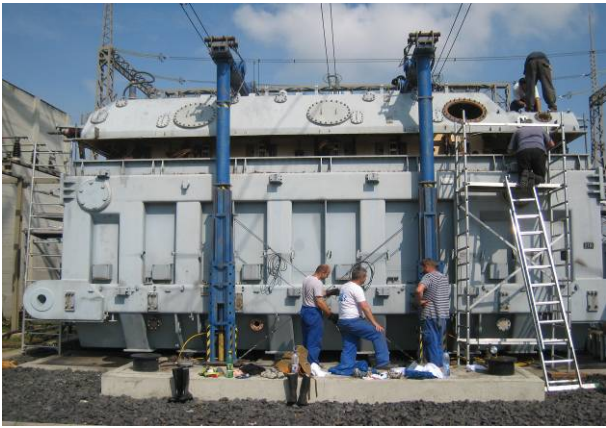
The on-site repair of high voltage transformers involves complex operations. They require a combination of a set of special processes supported by a group of transformer specialists. Among the transformer repair process, involving lots of various steps, the special un-tanking technology with using the "CRAB lifting system" was the most important (Figure 1).

**Figure 1:** Un-tanking with CRAB lifting system

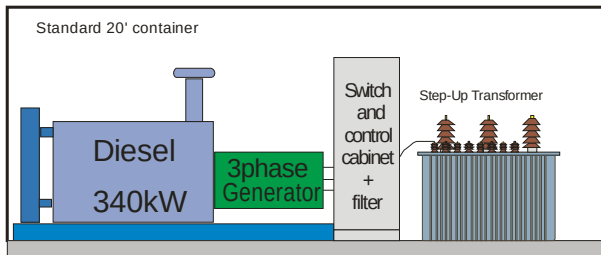
To perform on-site HV tests, a complete test container was built. It contains the necessary excitation and the measuring instrumentation for the on-site PD testing of transformers (Figure 2).

**Figure 2:** Test container for on-site induced HV test on transformer with PD measurement.

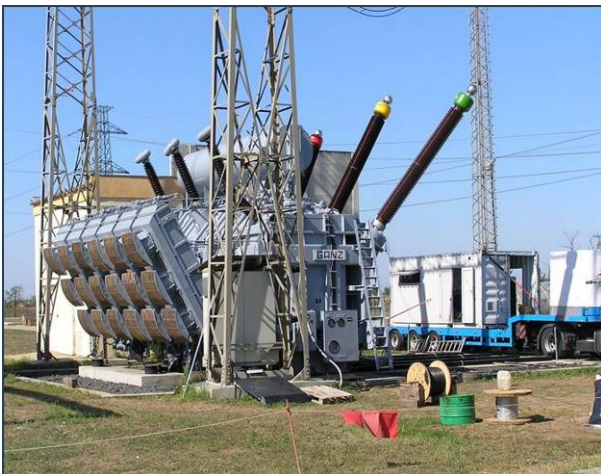
These transformers were energised from the tertiary winding using a three-phase supply from a diesel generator connected via a intermediate transformer to the tertiary winding (Figure 2, Figure 3). In our cases the capacitor bushings with tap-off connectors are available and the measuring impedance is directly connected to the bushing tap-off.

**Figure 3:** On-site induced HV test on transformer

Figure 3 shows a large 250 MVA, 400/120/18 kV transformer under dielectric testing in a substation when the high voltage electric AC tests was perform with a motor-generator mobile group built into a container.
