OUTDOOR INSULATORS AND HOUSINGS BREAKDOWNS CAUSED BY POLLUTION

Abstract: A heavy pollution on outdoor insulators causes electrical discharges, flashovers, surface erosion or tracking. In extremely cases the dielectric breakdowns occur. In this paper the breakdowns of four insulators has been shown: porcelain bushing insulators on rectifier set ups of electrostatic precipitators, the porcelain fuse cutouts, a porcelain housing of metal oxide surge arrester and polymer concrete insulators. The analysis of other damages of condenser bushings and instrument transformers published in the literature has led us to a hypothesis that a part of these failures could be initiated or accelerated by external pollution.

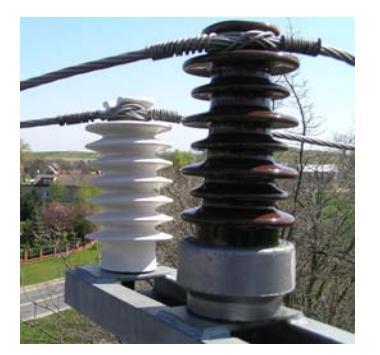
Figure 6: Polymer concrete insulator (on the left) and porcelain insulator of 20 kV line.

Twenty of prototype PC insulators manufactured in Poland were installed on 20 kV lines near Glogow in 1999 (Figure 6). The specific leakage distance of insulators on overhead line amounted 38 mm/kV phase to ground (22 mm/kV phase to phase). The overhead 20 kV lines are situated in clean rural areas and any traces of erosion were found on these insulators after 11 years of service. Five strings consisted of three or four such insulators were tested at Glogow test station under 75 kV from 1999 to 2010. The specific leakage distance of the string consisted of three insulators was very short and amounted 18 mm/kV phase to ground (11 mm/kV phase to phase). Unfortunately, the string of four insulators with the specific leakage distance of 24 mm/kV phase to ground failed after 12 months. The results of these long term experiments are shown in table 2.
