GLASS CAP-AND-PIN INSULATOR STRINGS UNDER HVDC CONDITIONS: PRELIMINARY RESULTS OF INVESTIGATIONS INTO THE INFLUENCE OF SHATTERED DISCS ON INSULATION STRENGTH

N. Parus^{1*}, N. Mahatho¹, T. Govender¹, E. Marshall¹, P.V. Goosen¹
E. Greyling¹ and G.C Sibilant²

¹Eskom Holdings SOC Ltd, Johannesburg, South Africa

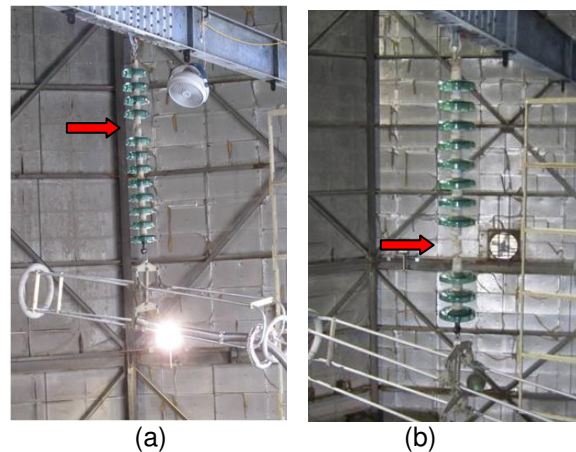
Figure 3(a): Photograph of test setup showing a broken disc located 2/3 up the string **(b)** two shattered discs 1/3 up the string.
