ELECTRICAL PERFORMANCE AND POLLUTION ANALYSIS OF IN-SERVICE HVDC GLASS DISCS

T. Govender^{1*}, N. Mahatho¹, N. Parus¹, E. Greyling¹ and H. A. Roets²

¹Eskom Holdings SOC Ltd, Johannesburg, South Africa

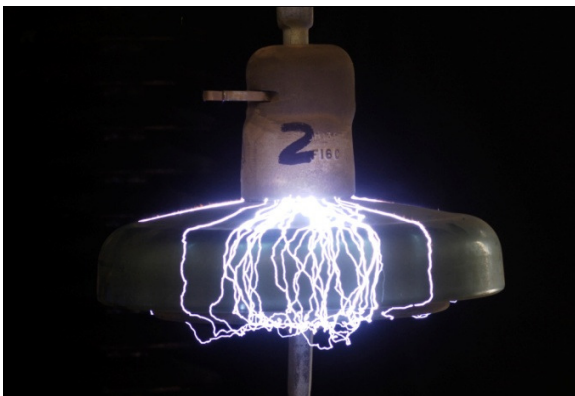
Figure 9: Recorded image of dry flashover.

The test setup consisted of a 250 kV polarity reversible DC test set, voltage divider, current limiting resistor and associated measurement and recording equipment. The test voltage is applied to the live end of each disc and slowly increased in one minute intervals until flashover across the entire unit occurs. For the wet procedure the insulator disc is lightly wetted with de-mineralised water in a uniform manner before the test voltage is applied. A minimum of five applications of the test voltage is used to determine both the one minute withstand value as well as the test voltage at flashover for both the wet and dry scenarios.
